# Restoring Tranquility

A proposal to improve the safety  
of Central Park's paths for everyone

**Published**  
7/26/2016

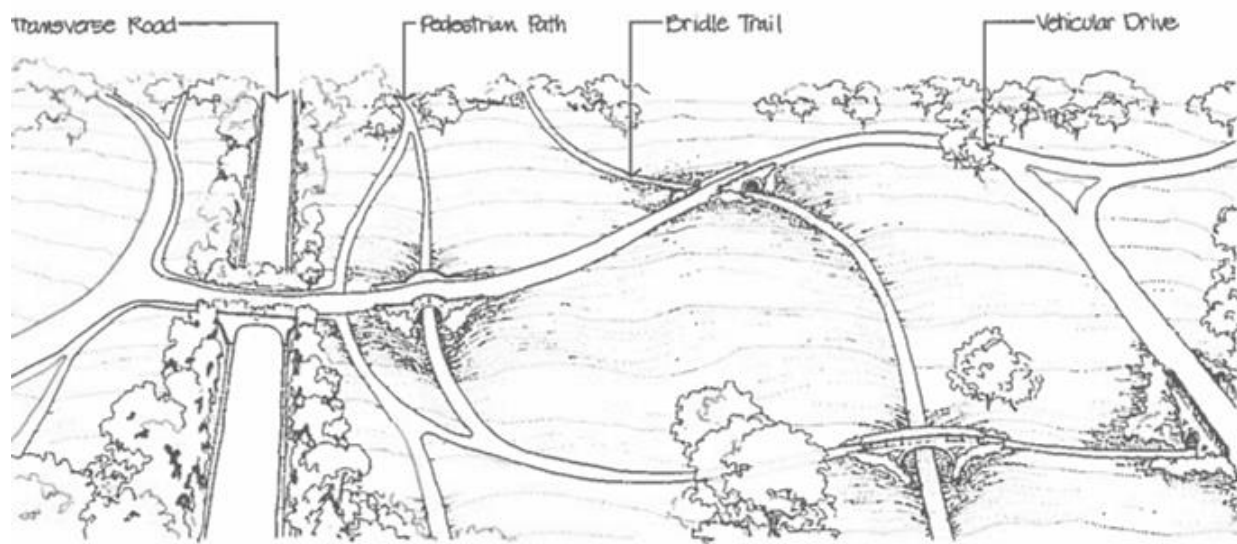
The various elements of Central Park's circulation system – pedestrian paths, Bridle Trail, transverse roads and vehicular drives – are grade separated, thus preventing the interruption of the flow of one traffic mode by another.

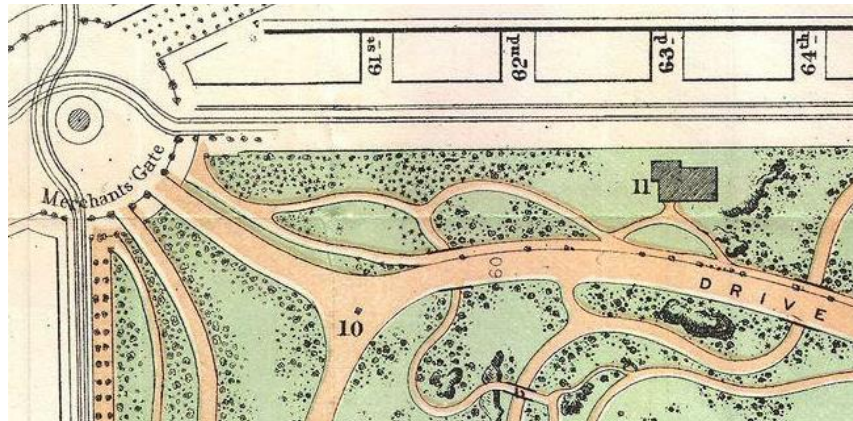
The Carriage Drive exiting the park is now a pedestrian path. The original pedestrian path located nearest to Central Park West (where Greyshot Arch exists) is now rarely used.

Signage at Columbus Circle could help pedestrians seeking Heckscher Playground or other nearby attractions to cross safely using Greyshot Arch. It would also help to designate the initial carriage path as a path for runners and cyclists rather than casual park-goers. Lanes similar to those found on the loop and signage could help to accomplish this.

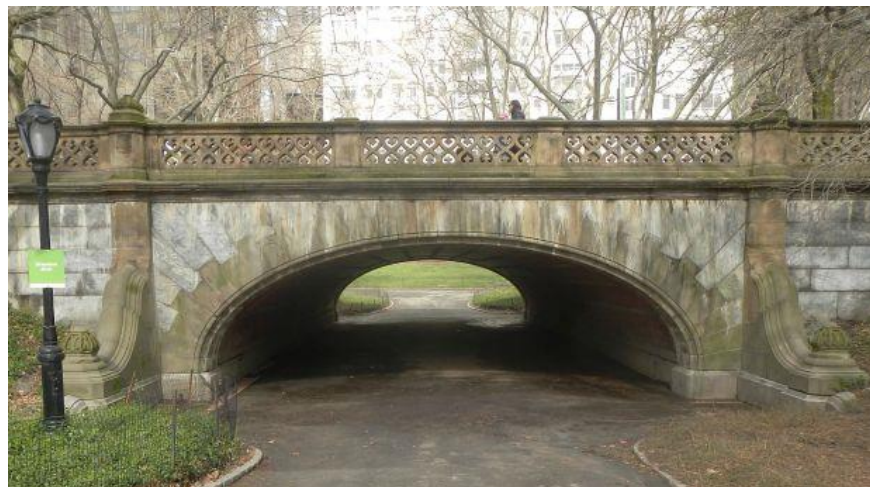
Greyshot Arch

Greyspot Arch itself would benefit from proper underside lighting and better drainage so that it doesn't flood when it rains. Darkness and puddles deter people from utilizing this arch. Proper lighting would make it a piece of architecture to be admired.

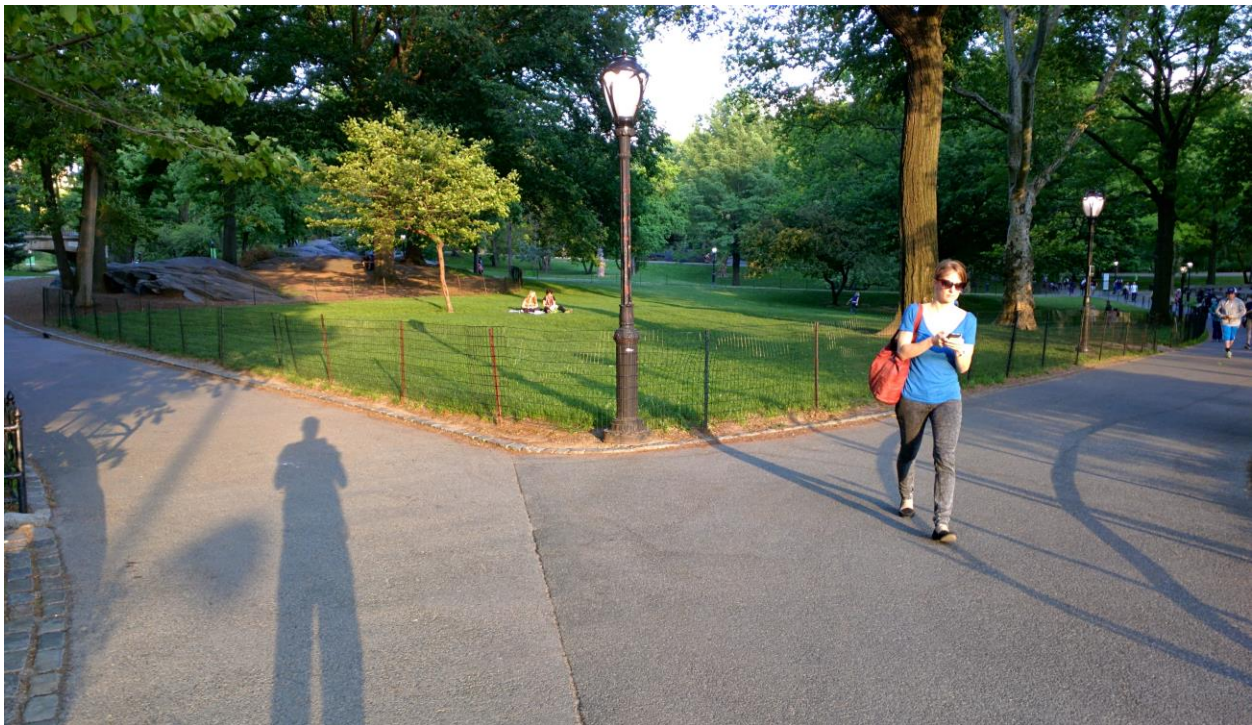
Left leads to an arch. Right leads to a dangerous crosswalk.

Upon entering the park, visitors are faced with a decision to walk left or right. The path to the left leads to Winterdale Arch while the path to the right leads to a crosswalk that's at the base of a steep and winding hill on the Central Park loop. As the above photo shows, you can see both the arch and the crosswalk from the juncture. In an ideal world, the path to the right would not exist. In the long-term it would be advisable to restore it to grass as it was originally. In the short-term, a sign listing popular attractions should be added to this area directing

people to the arch. As with Greyspot Arch, and all the park's arches, Winterdale Arch would benefit from lighting that properly illuminates the underside of the arch.

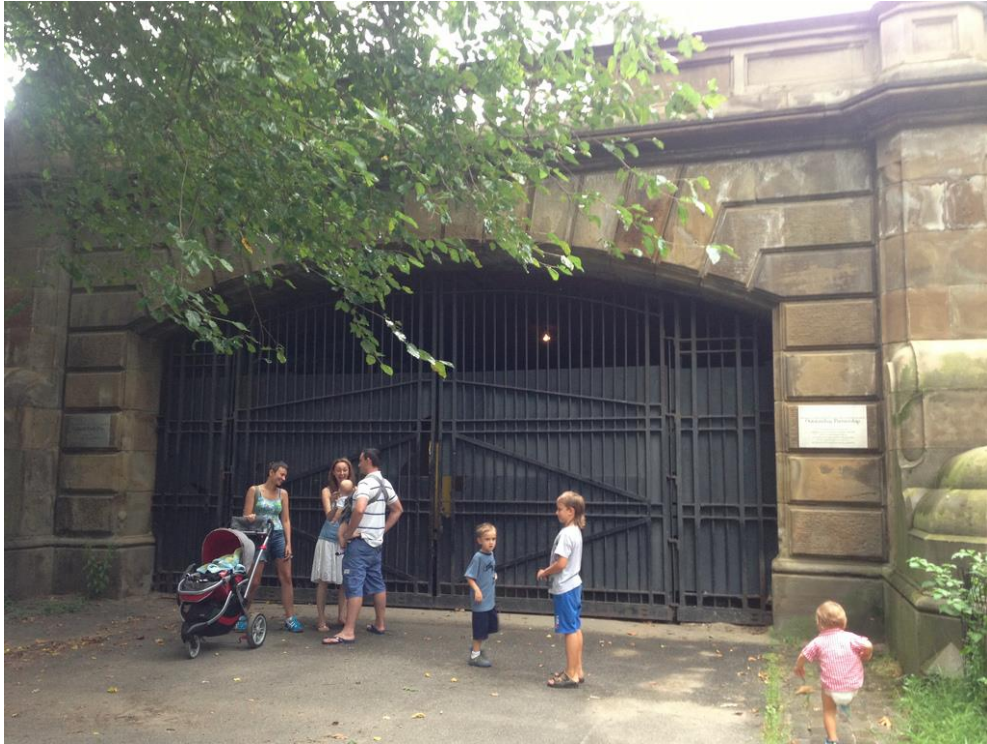
In between Wollman Rink and the Central Park Zoo, pedestrian traffic comes to a stop. Prior to the 1980s, Green Gap Arch led to the east side of the park but it was temporarily closed during the modernization of The Central Park Zoo. 36 years later it remains closed. In order to exit the park, pedestrians must climb stairs which are carved into a nearby rock outcropping. At the top of the stairs they must cross a busy two-way section of the park's main drive. Plans should be created to reactivate Green Gap Arch and allow pedestrians to continue their journey from the west side of the park to the east side of the park.

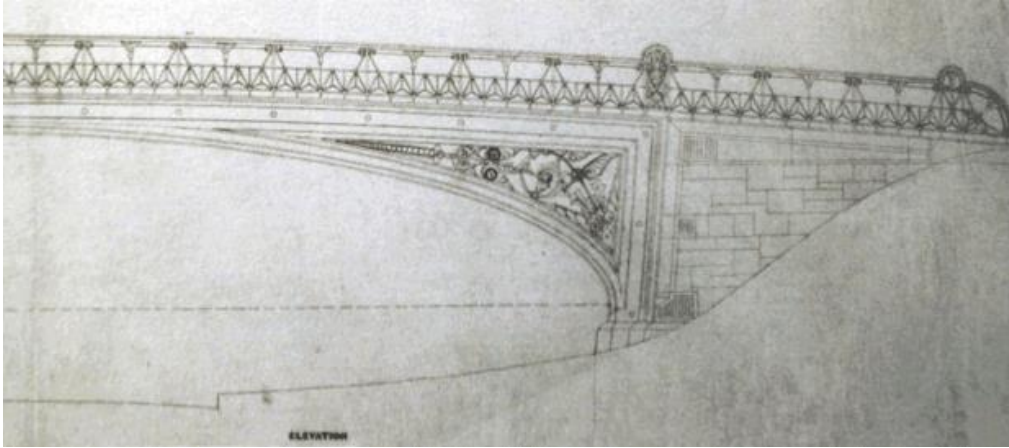
Olmsted and Vaux were hired to add Outset Arch to Central Park in 1873. The arch could be recreated using drawings which exist at The Municipal Archives. The Central Park Conservancy undertook a similar recreation when it restored Oak Bridge to Central Park in 2009. The top of this arch could connect to the park's loop and allow pedestrians to safely walk under it. This type of space would create a main entrance to Sheep Meadow and give access to other main park attractions including The Mall and Bethesda Terrace. More immediately, renderings and feasibility studies would determine how this might occur.

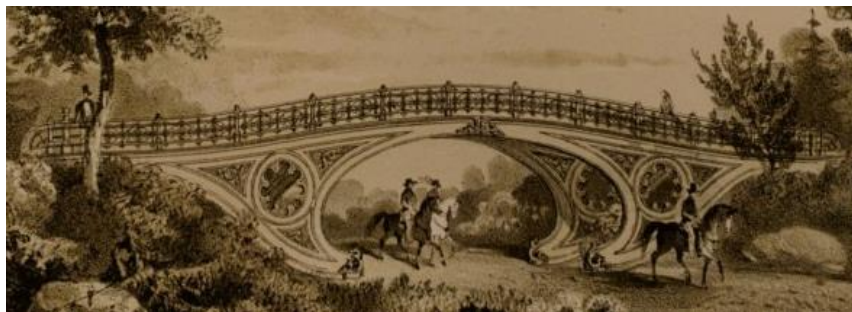
Just as Sheep Meadow and Tavern on the Green, Rumsey Playfield (home to numerous concerts and movie screenings) on the east side of the park results in large crowds of people crossing the street en masse for special events. As this is a modern park addition, there is no arch here to help with crossing. It was in this part of the park that 75-year old Irving Schachter was fatally struck in 2014. This area of the park could house a recreation of Oval Arch which was demolished by Moses to make room for the expansion of the Heckscher Playground.

A feasibility study and renderings should be done to determine how Oval Arch could best link pedestrians to Rumsey Playfield.
